November 18, 2024

Subject: State Farm Insurance Building  
Structural Assessment Letter

Project Address: 4815 Main Street  
Yorba Linda, CA

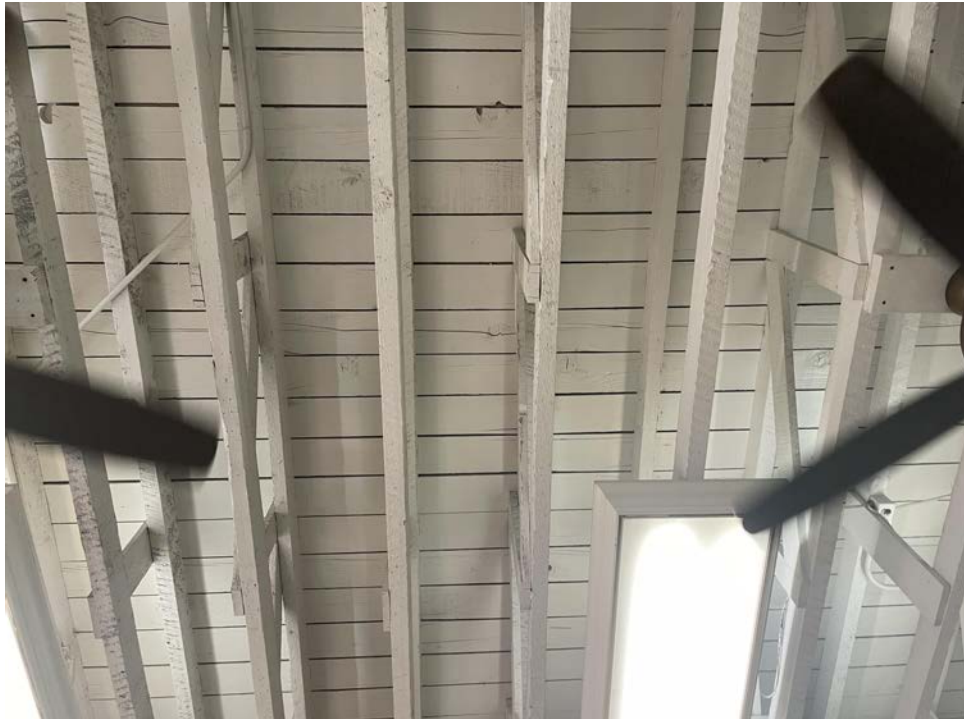
**Photo #4: Roof Framing**

- Roof Framing:
  - The existing wood plank sheathing and wood trusses appear to be in sound structural condition at most locations. There were some locations where the planks were cracked, most likely due to wood drying over time.
  - There were a few isolated locations where the roof framing felt soft while walking atop the roof. These locations were at the front of the building which coincided with locations of visible water intrusion inside the building.
  - See attached **Photo #4** for typical roof framing view from below.
- Exterior Wall Framing:

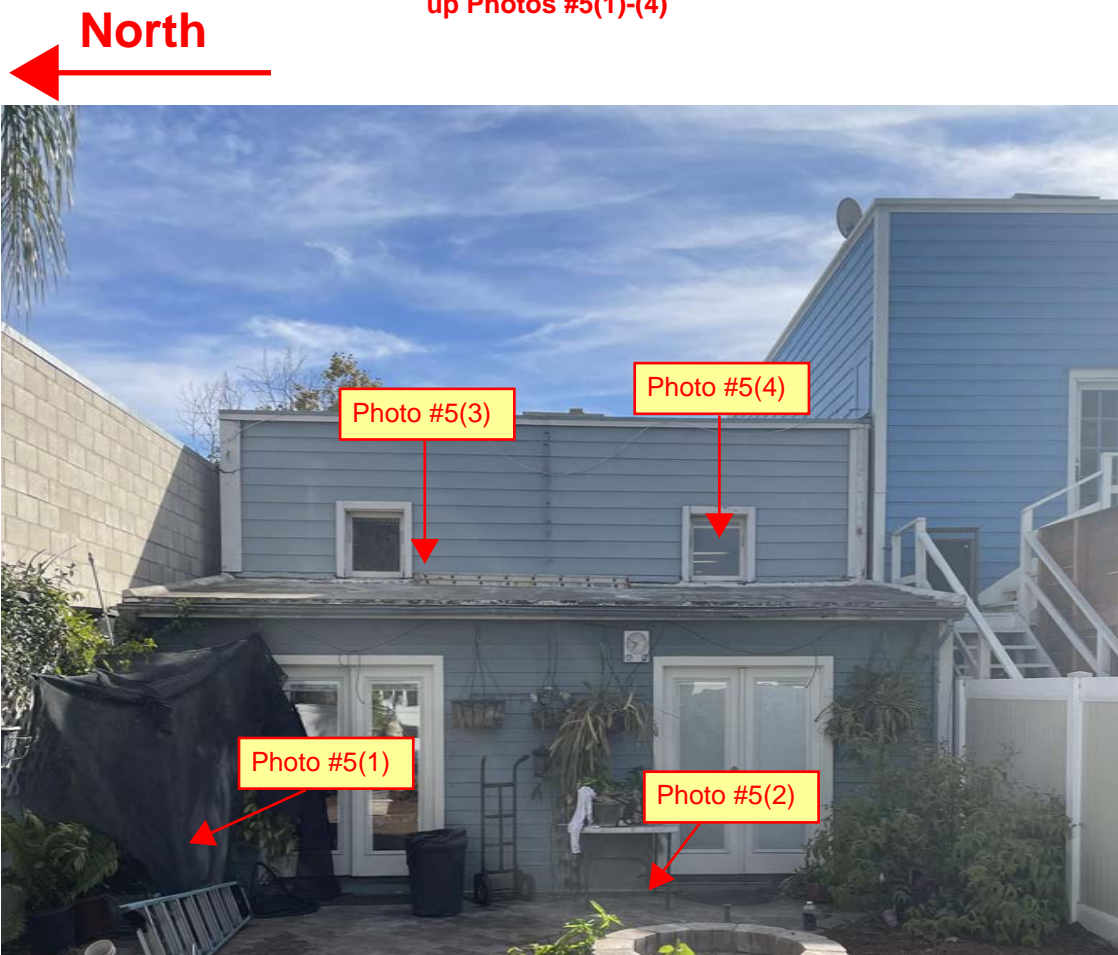
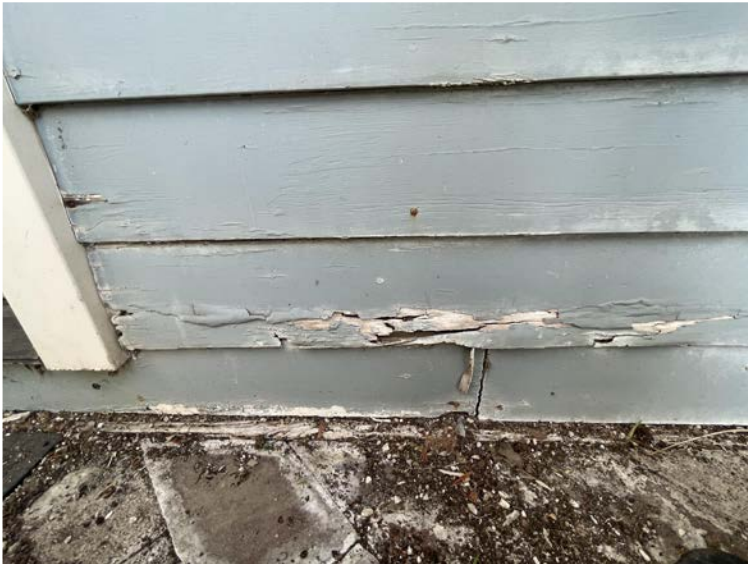
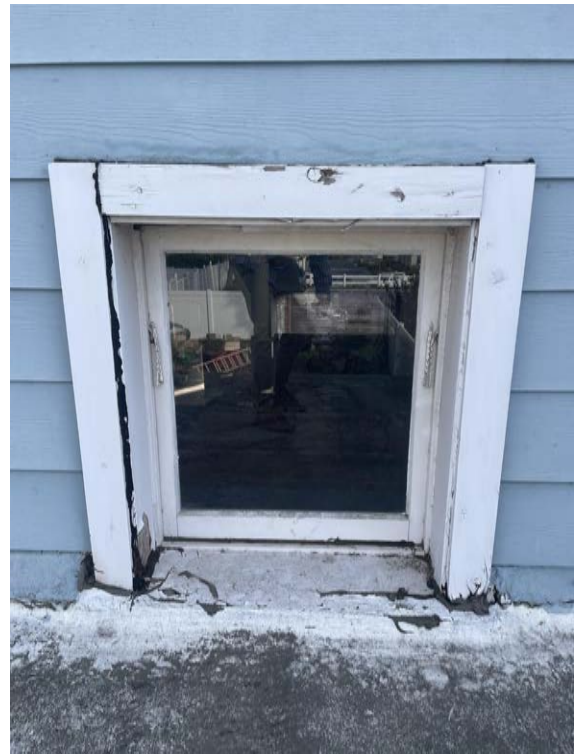
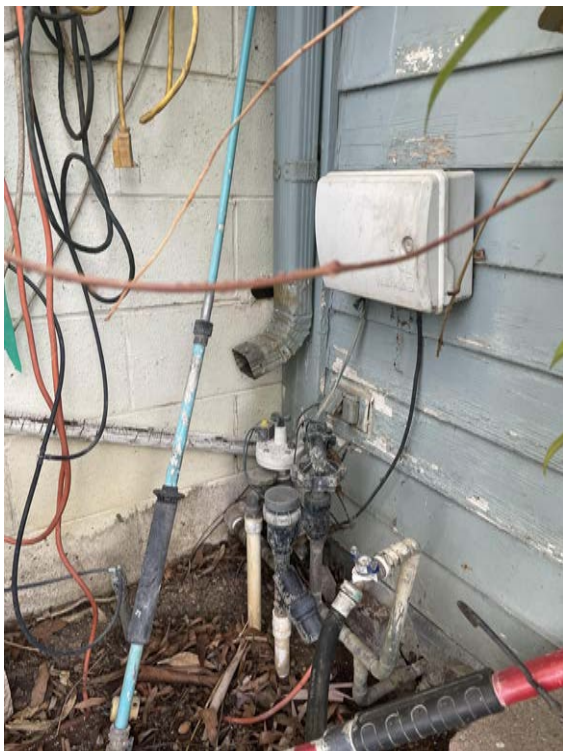
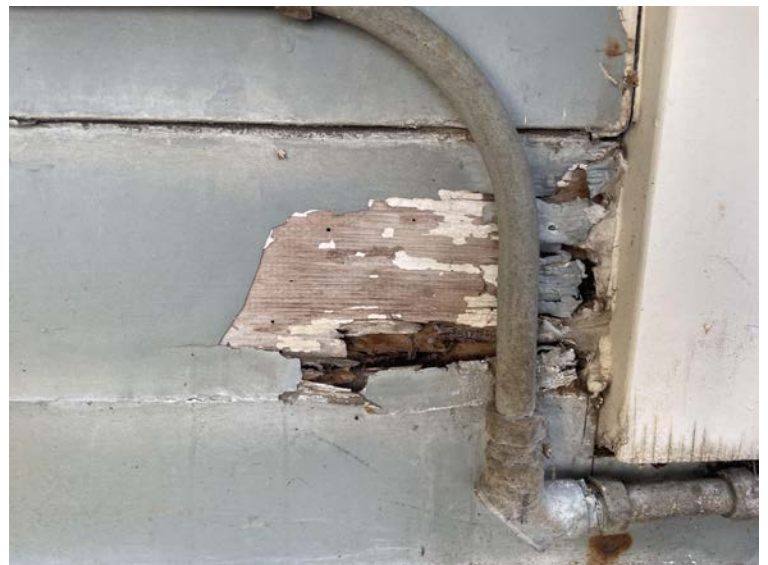
**Photo #5: East Exterior Wall Water Damage**

- Visual review of the north and south wall exterior siding was limited due to the close proximity of the adjacent buildings.
- Water damage and dry rot of the west exterior wall was observed. See attached **Photo #5**.

- **Based on our visual review of the accessible exterior walls, observed roof leaks at exterior walls, and from past experience of similar buildings; we anticipated that many of the many of the exterior wall wood siding planks, wood studs and sill plates will have dry rot.**

- The east and west exterior walls provide lateral bracing for north/south direction loading.
  - The west wood plank siding shearwall would not comply with the 2022 CBC detailing and strength requirements; however, it does provide nominal seismic load resistance. The wall anchorage to foundation was not visible for review. See **Photo #5** for west wall elevation.

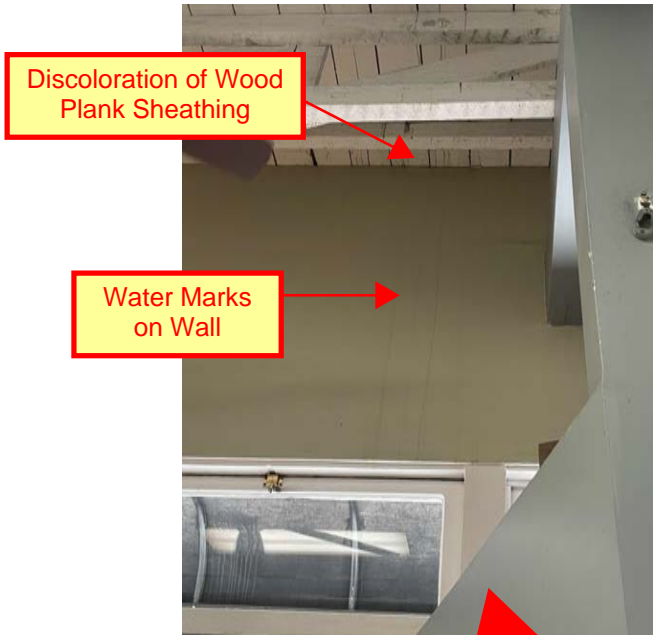
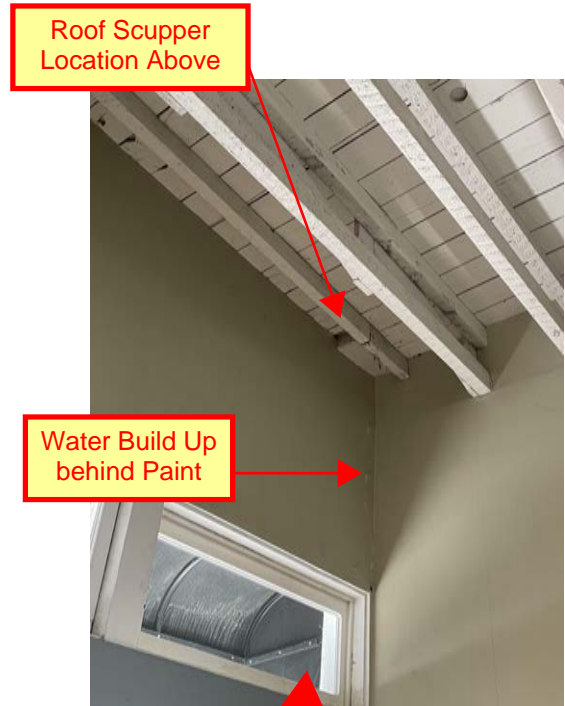
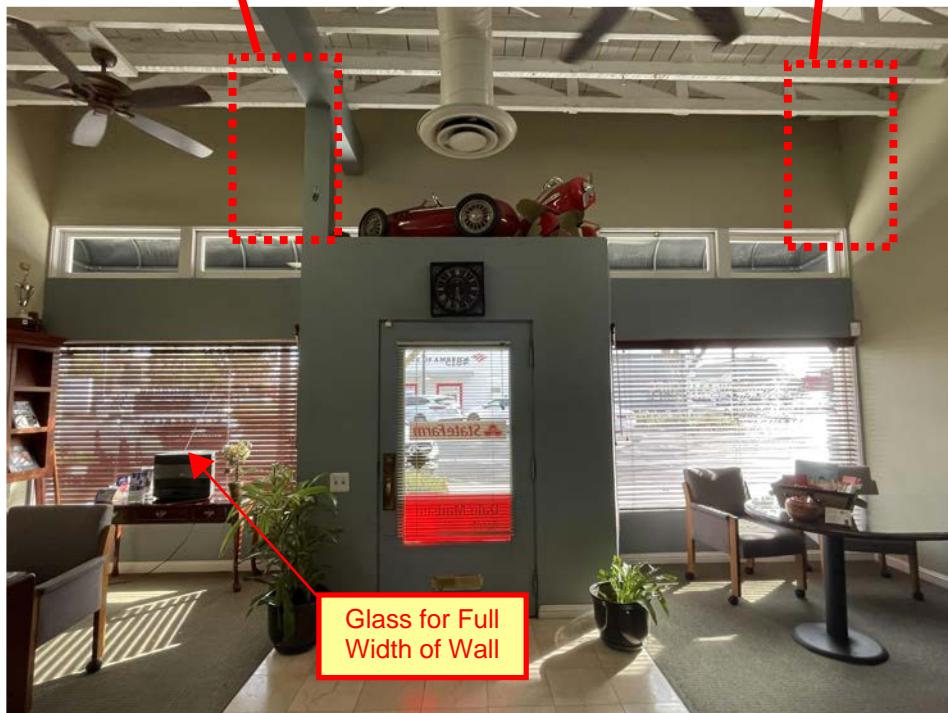
**Photo #6: Water Leaks (East Wall)**

- Water leaks were observed at multiple locations along the inside face of the exterior walls. See attached **Photo #6** and **Photo #7**.
- The north and south exterior walls are exposed to weather without ability to maintain their condition due to the close proximity of the adjacent buildings. There appears to be flaking of the paint and/or wood siding. See attached **Photo #8**.

**East Wall Elevation from Inside Face**

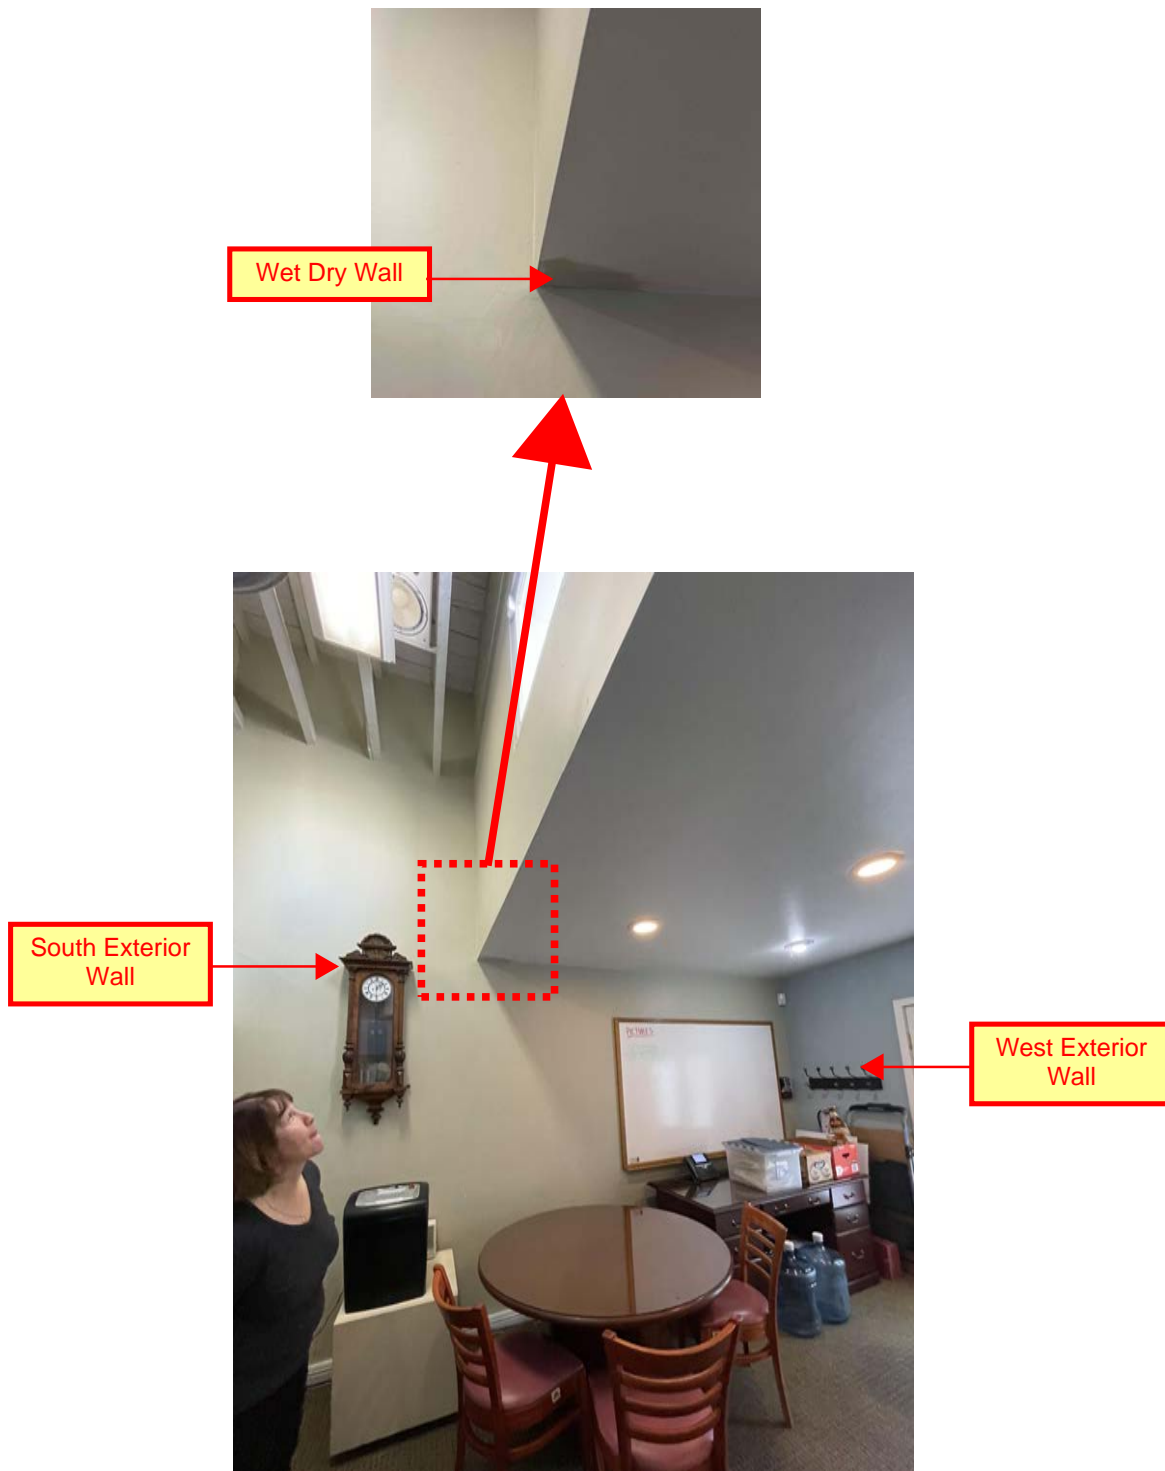
Photo #7: Water Leaks (West Wall)

South/West Wall Elevation from Inside Face

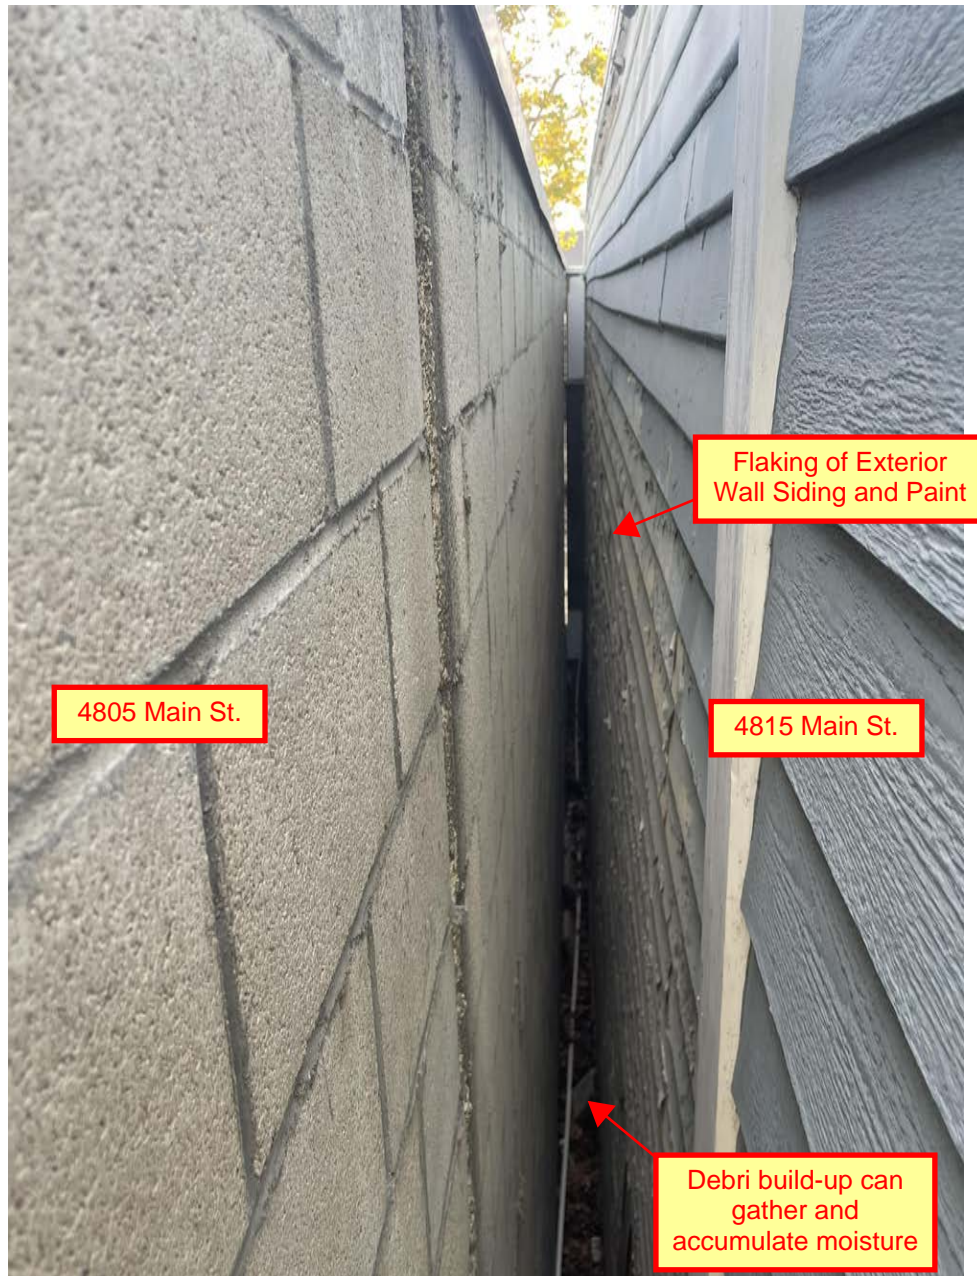
**Photo #8: North Exterior Wall at Adjacent Building**

- The existing exterior wood wall construction does not provide sufficient fire-resistance rating along a property line as required by the 2022 CBC.
- The existing north and south exterior bearing walls have been and will continue to be exposed to weather which compromises the structural integrity of the walls. This includes both the wood plank siding, which serves as structural shear resistance and weather resistance, and the structural wood studs. The proximity to the adjacent buildings does not allow the exterior face of these walls to be maintained, thus we anticipate continued deterioration of the existing wood wall framing or any new wood framing added to the existing wall.

- Concrete Masonry Unit (CMU) exterior walls at the north, south and west faces. CMU wall construction will be more durable and weather resistance which is necessary due to the inability to maintain the walls adjacent to the neighboring buildings. CMU walls will also provide the necessary fire-resistance rating required by the 2022 CBC.
- Provide a steel moment frame at the east face storefront along Main Street. A steel moment frame could be designed to satisfy the strength and stiffness requirements of the 2022 CBC and continue to allow for an open storefront concept. An Architect would be able to design an open storefront with an aesthetic consistent with the original building or time period.

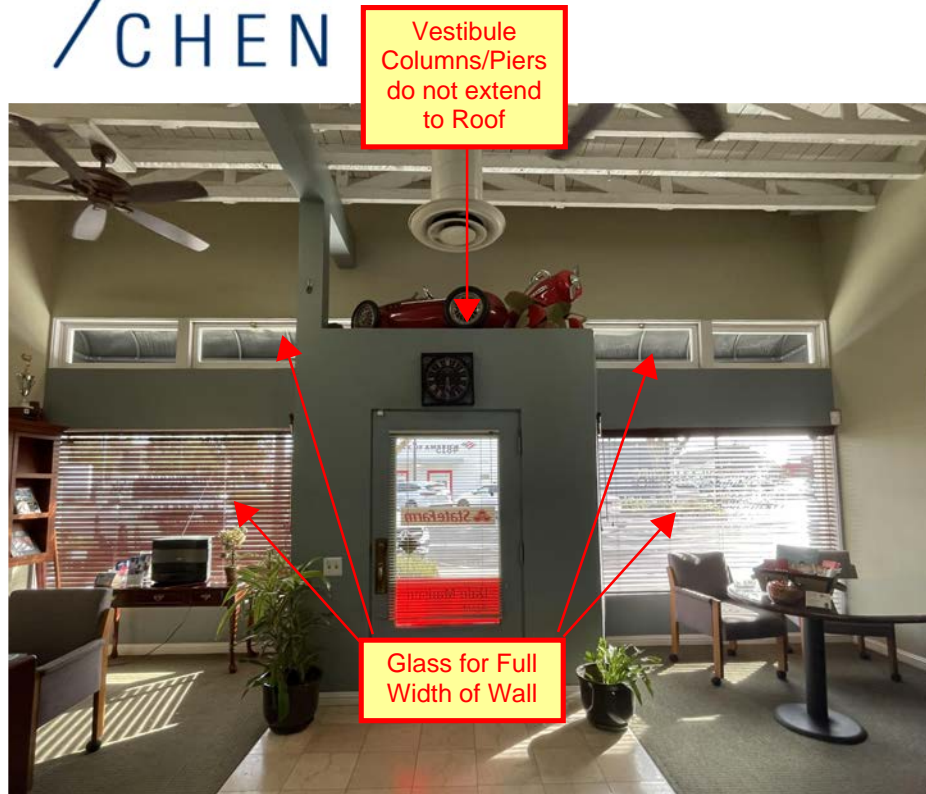
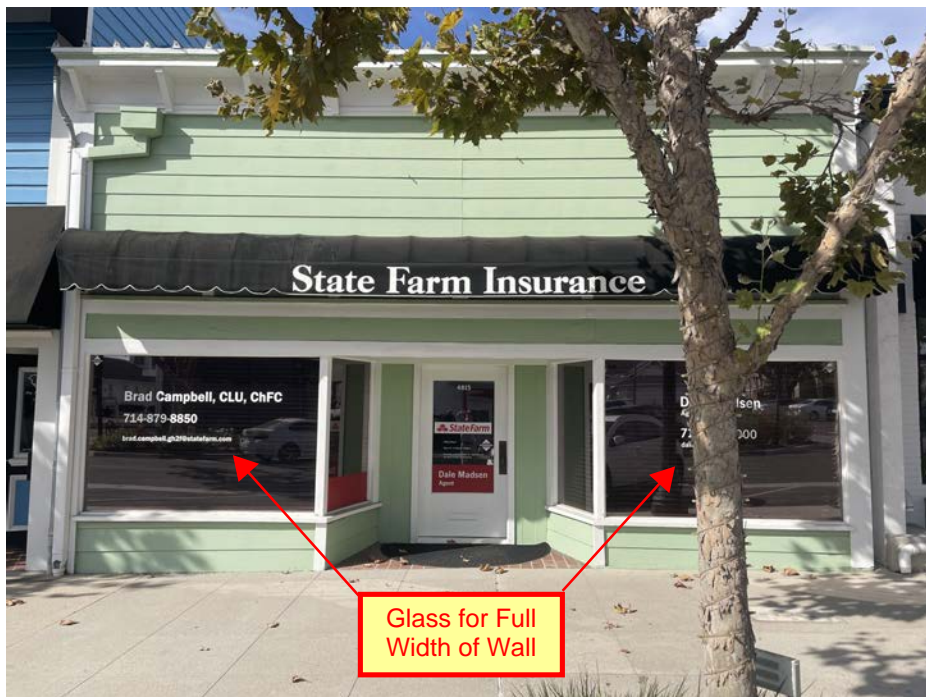
Photo #9: East Wall with No Lateral System

- The east exterior wall has no visible lateral load resisting system. There is glass for the full width of the wall for the lower half of the wall elevation. See **Photo #10** for east wall elevation. **This is consistent with intent of ASCE7-16 Table 12.3-2 1B & 5B soft story and weak story vertical irregularities which are not permitted in areas of high seismicity.**

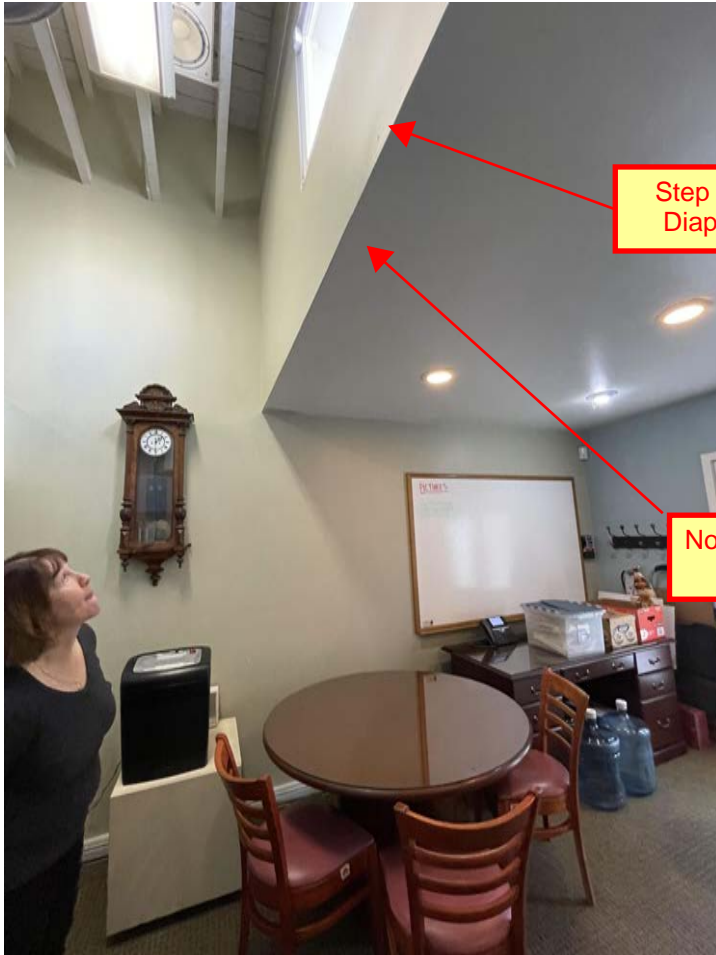
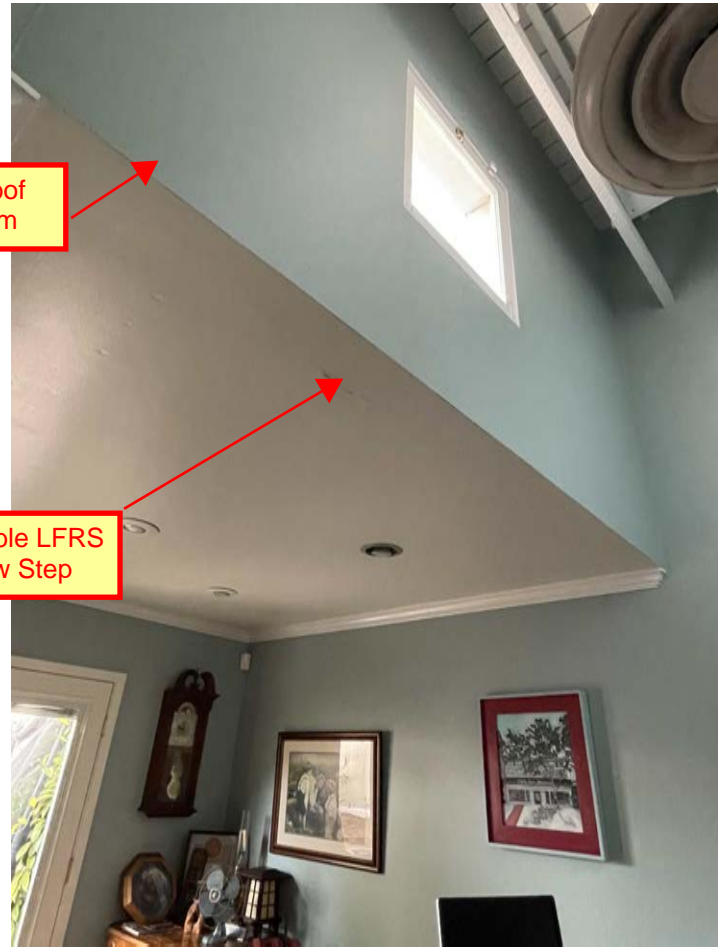
Photo #10: Roof Diaphragm Step

- There is a vertical step in the roof diaphragm at the original building and addition interface. There is no visible lateral load resisting system beneath the step, thus the seismic load transfer must transfer through this step. **This is consistent with of ASCE7-16 Tables 12.3-1 & 12.3-2 for horizontal and vertical irregularities which requires structural framing to be design for amplified forces. These amplified forces did not existing at the time of the original construction and would not be considered in the existing design.**

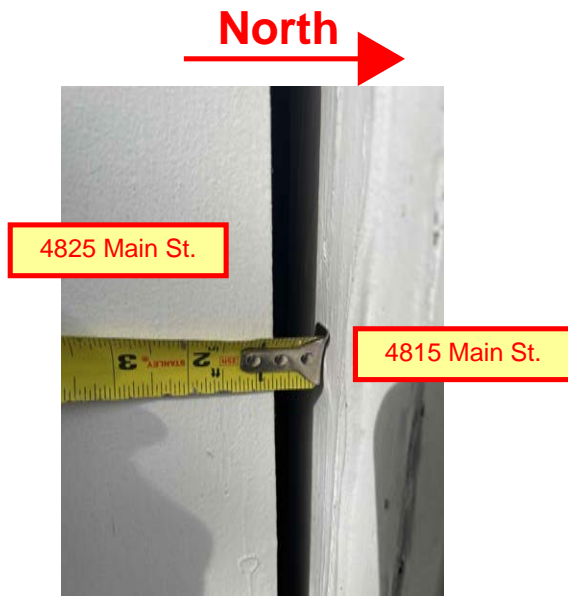
- The structural separation at the south side of the building is approximately 1 inch. See attached **Photo #11**.
- **The existing structural separation at the south side of the building does not comply with the requirements of the 2022 CBC. Lack of structural separation could result in pounding between adjacent buildings during a seismic event.**
- Fire-Resistance Rating at Exterior Walls:
  - 2022 California Building Code Table 705.5 requires 1-hour fire-resistance rating for “B” occupancy adjacent to property lines.
  - **The existing exterior wood wall construction does not provide a 1-hour fire-resistance rating as required by the 2022 CBC.**

- The existing structural separation between the south exterior wall of the building and the 4825 Main Street property is small and significantly less than what is required by the 2022 CBC. Pounding between the two buildings is anticipated during a design level seismic event which could lead to significant structural damage of both buildings. The existing structural separation is so small that structural retrofit to stiffen the building would not solve the issue.

**Structural Separation  
at South Face Exterior Wall  
(Measured at Front of Building)**

- Plywood sheathed roof over wood joists that span between exterior walls. Roof framing would be designed to provide the necessary strength and stiffness to brace the exterior CMU walls for out-of-plane loads.
- Concrete slab on grade with shallow foundations. A concrete slab on grade will have superior strength and stiffness to brace the exterior CMU walls for out-of-plane loads, as opposed to a raised wood floor system.
- Relocate the south exterior wall to the north to provide an adequate structural separation between the 4825 Main Street building as required by the 2022 CBC. The anticipated structural separation would be approximately 6 inches, thus the south wall would need to shift north approximately 5 inches from its current location.

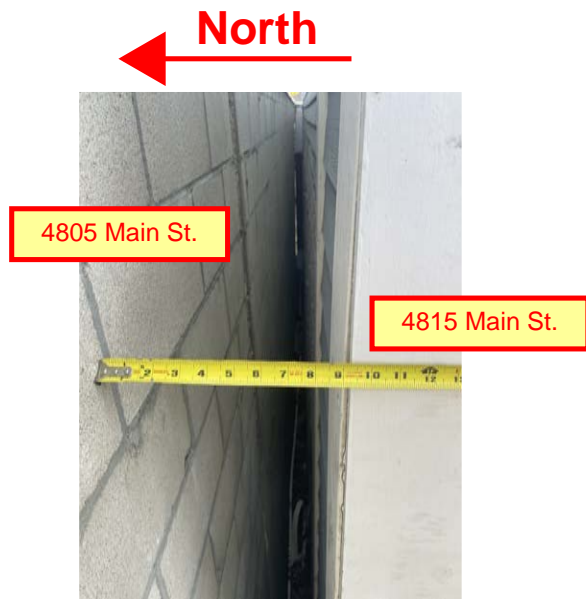
- The structural separation at the north side of the building is approximately 8 inches. See attached **Photo #11**.

**Structural Separation  
at North Face Exterior Wall  
(Measured at Rear of Building)**

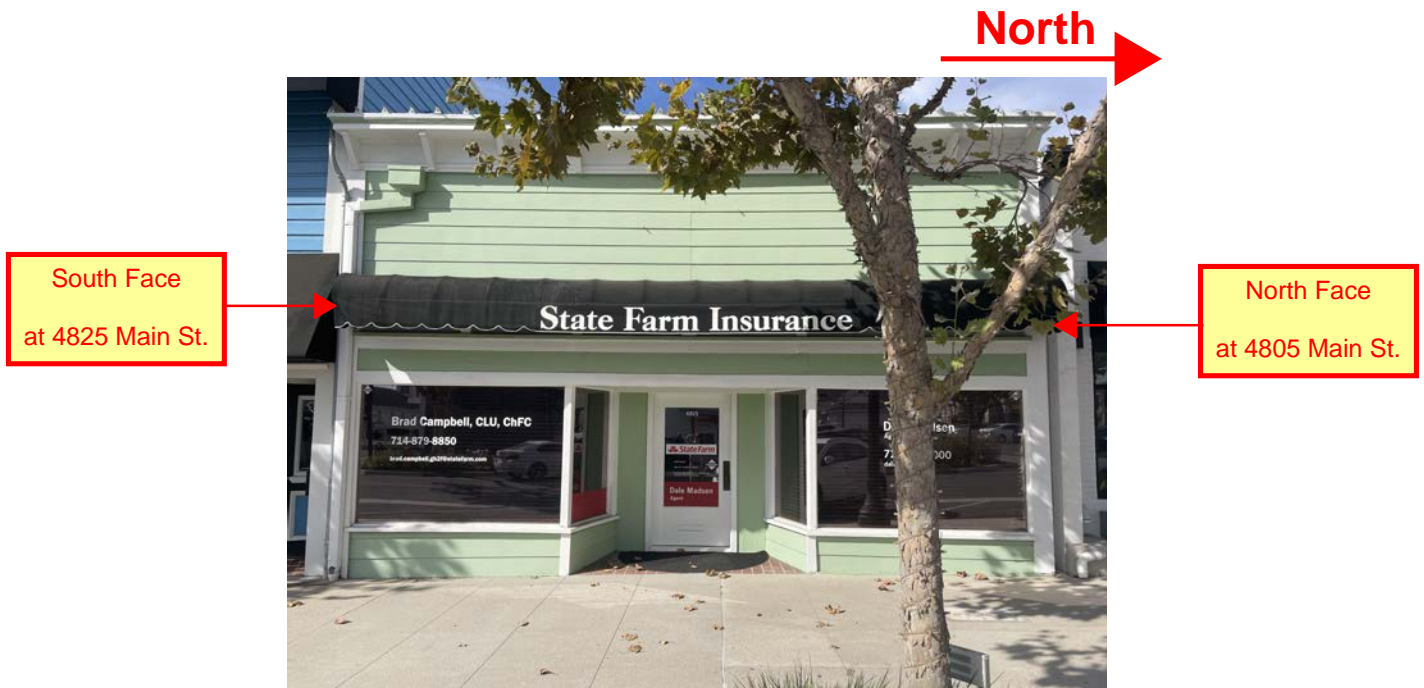
**Photo #11: Structural Separation at Adjacent Buildings**

- Structural Separation:
  - ASCE 7-16 Section 12.12.3 requires a structural separation between adjacent buildings. The intent of the structural separation is to avoid or limit pounding of adjacent buildings during a seismic event. The required structural separation is approximately 6 inches.
