# PRIMARY RECORD

\*Resource Name or # (Assigned by recorder) 4815 Main Street

P11. Report Citation: (Cite survey report and other sources, or enter "none.") City of Yorba Linda Citywide Historic Resources Survey Report

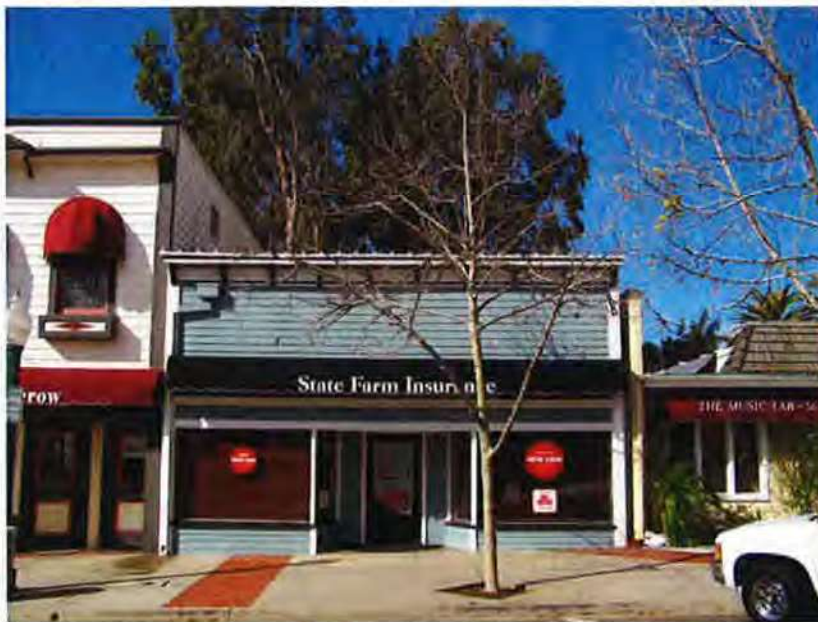
\*P5a. Photograph or Drawing (Photograph required for buildings, structures or objects)

Orientation: Primary entry on Main Street facing east

Style: Western false front

Alterations: Storefront windows replaced; awning added

Character-defining Features: Bracketed cornice under parapet; wood door; wood siding; angled storefront bays

P5b. Description of Photo: (view, date, accession #) View looking west at the façade. Pictures taken February 12, 2009.

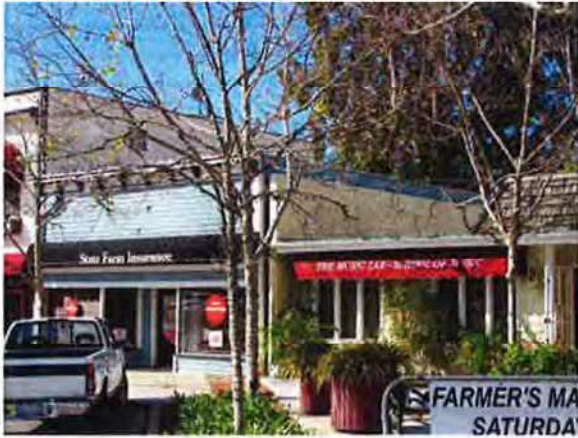
View looking southwest at the façade and north elevation.
