November 18, 2024

Subject: State Farm Insurance Building  
Structural Assessment Letter

Project Address: 4815 Main Street  
Yorba Linda, CA

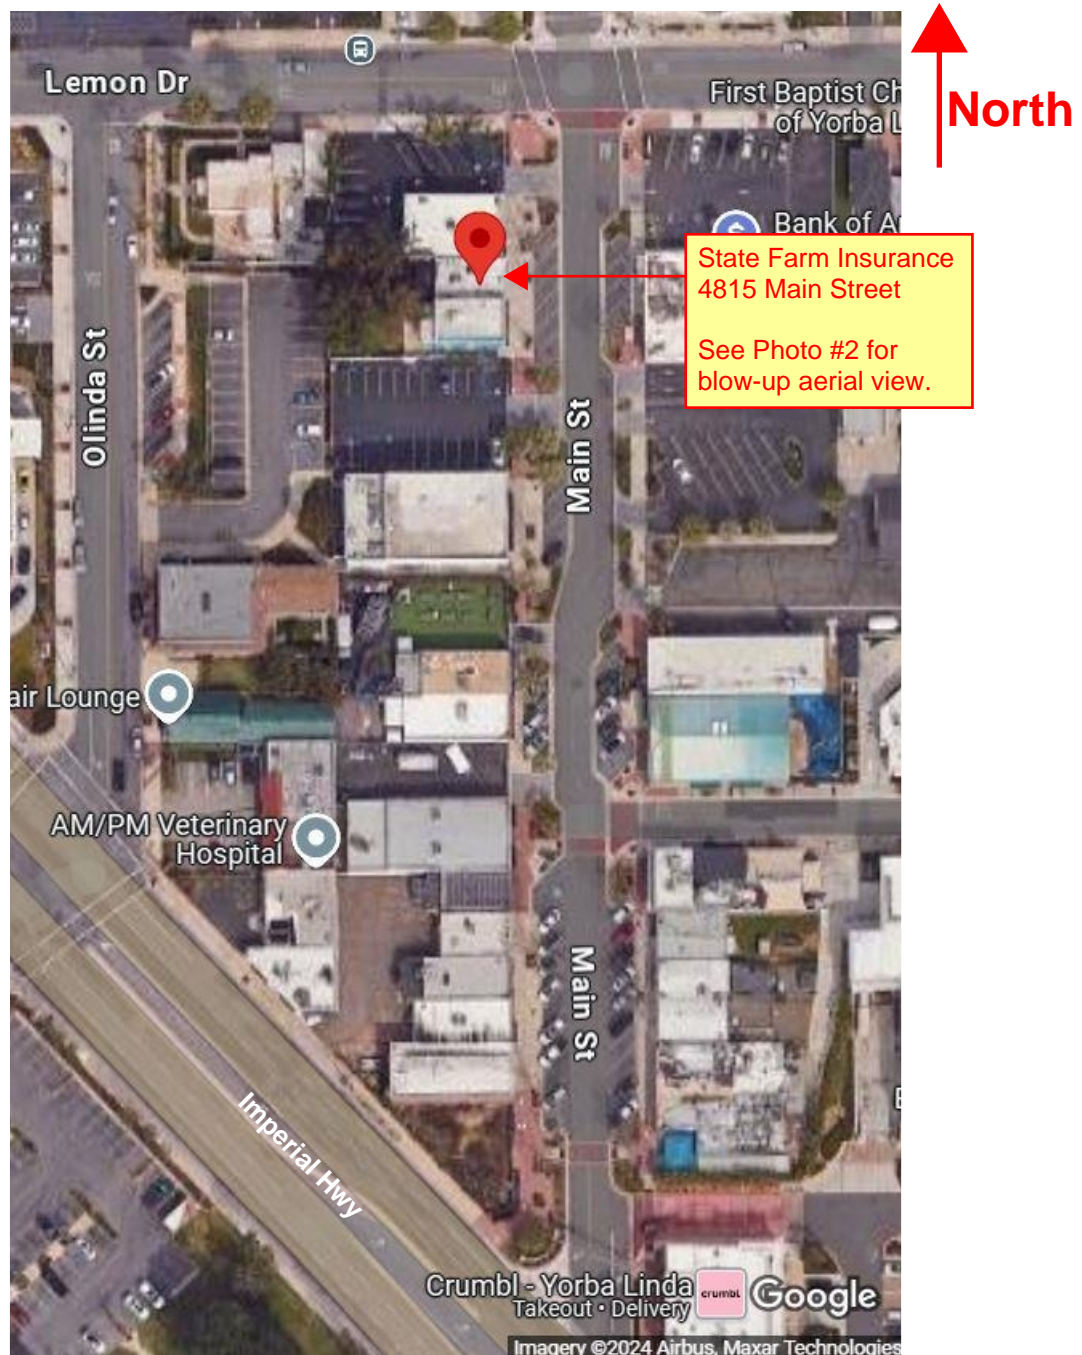
The State Farm Insurance building is located at 4815 Main Street in Yoba Linda, California. The building is located towards the north end of Main Street near the southwest corner of the intersection of Main Street and Lemon Drive. See attached **Photo #1**.

**Photo #1: Main Street Aerial View (via Google)**

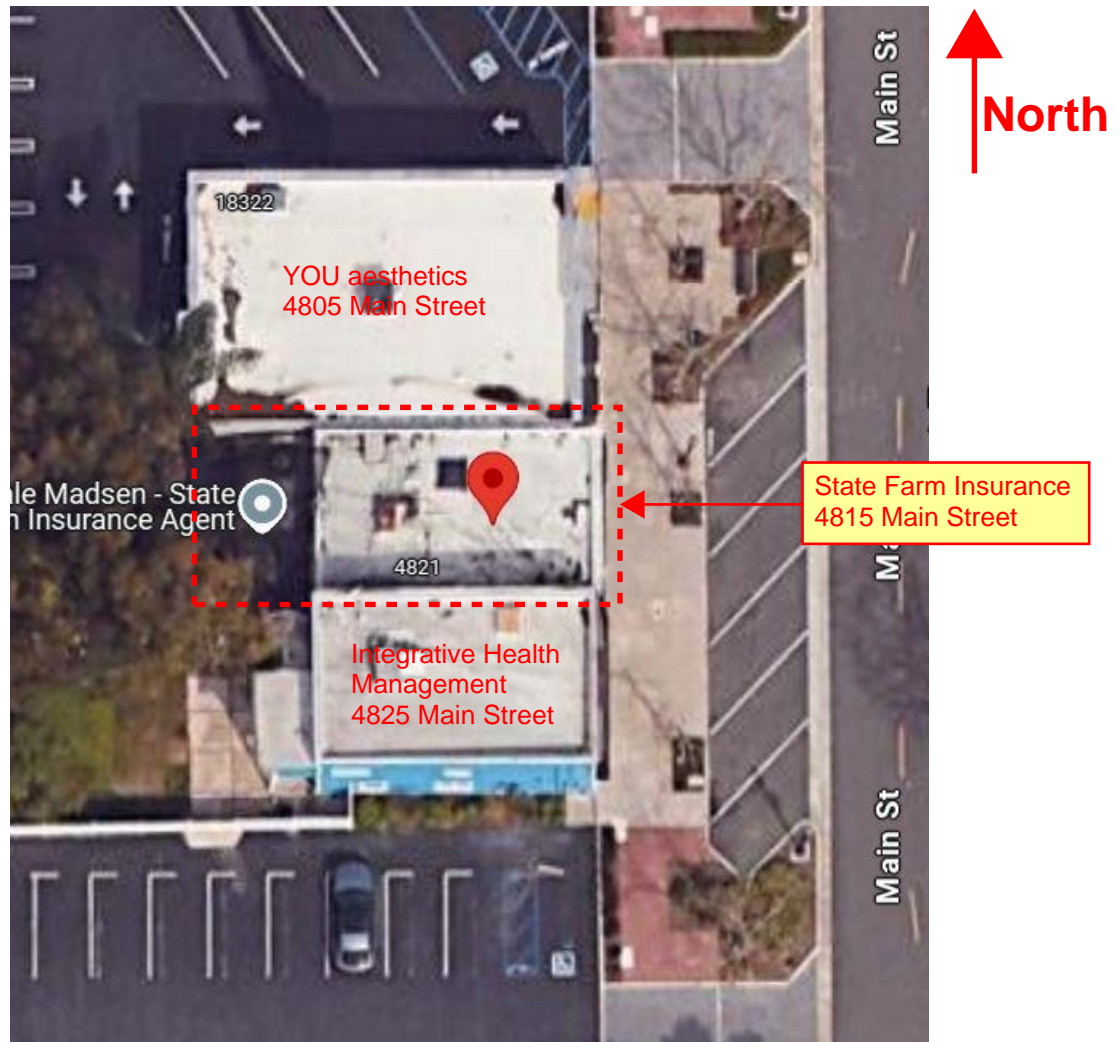
The building is located between two adjacent independent buildings; 4805 Main Street (occupied by *YOU aesthetics*) to the north and 4821 & 4825 Main Street (occupied by *Integrative Health Management* and *Professional Nurse Partners*) to the south. See attached **Photo #2 (Aerial View)** and **Photo #3 (Street View)**.

**Photo #2: Building Aerial View (via Google)**

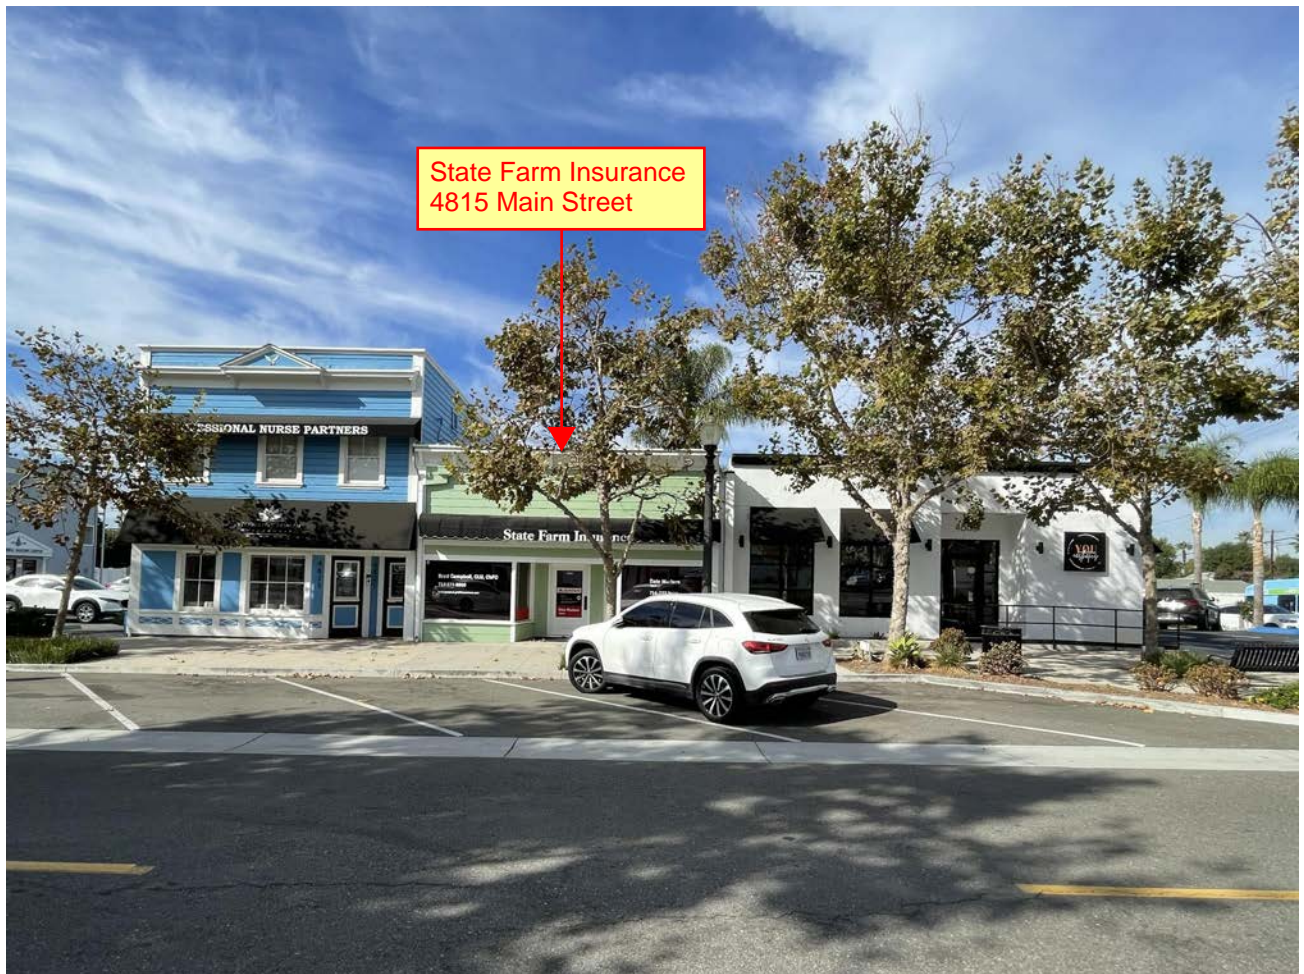
State Farm Insurance  
4815 Main Street

**Photo #3: Building East Elevation (from Main St)**
